# The Mars Rover Spirit FLASH Anomaly

Glenn Reeves

Jet Propulsion Laboratory (JPL)

**Abstract**—The Mars Exploration Rover “Spirit” suffered a debilitating anomaly that prevented communication with Earth for several anxious days. With the eyes of the world upon us, the anomaly team used each scrap of information, our knowledge of the system, and sheer determination to analyze and fix the problem, then return the vehicle to normal operation. This paper will discuss the Spirit FLASH anomaly, including the drama of the investigation, the root cause and the lessons learned from the experience.<sup>1,2</sup>

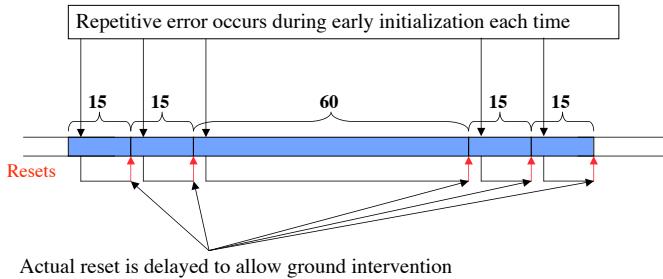
**Figure 1:** Delayed reset behavior

When the delayed reset time expires, the reset is initiated. The system keeps track of the number of repetitive resets and modifies the delayed reset time interval. The boot logic part of the software also keeps track of the number of initialization attempts and is designed to load and start alternating copies of the FSW with each reset. By design, the time period between resets is set to a fifteen minute delay for the first severe error, fifteen minutes for the second, and then one hour for the third. This pattern then

repeats (see Figure 1). Commands can be processed and communication windows can occur during the delayed reset period.

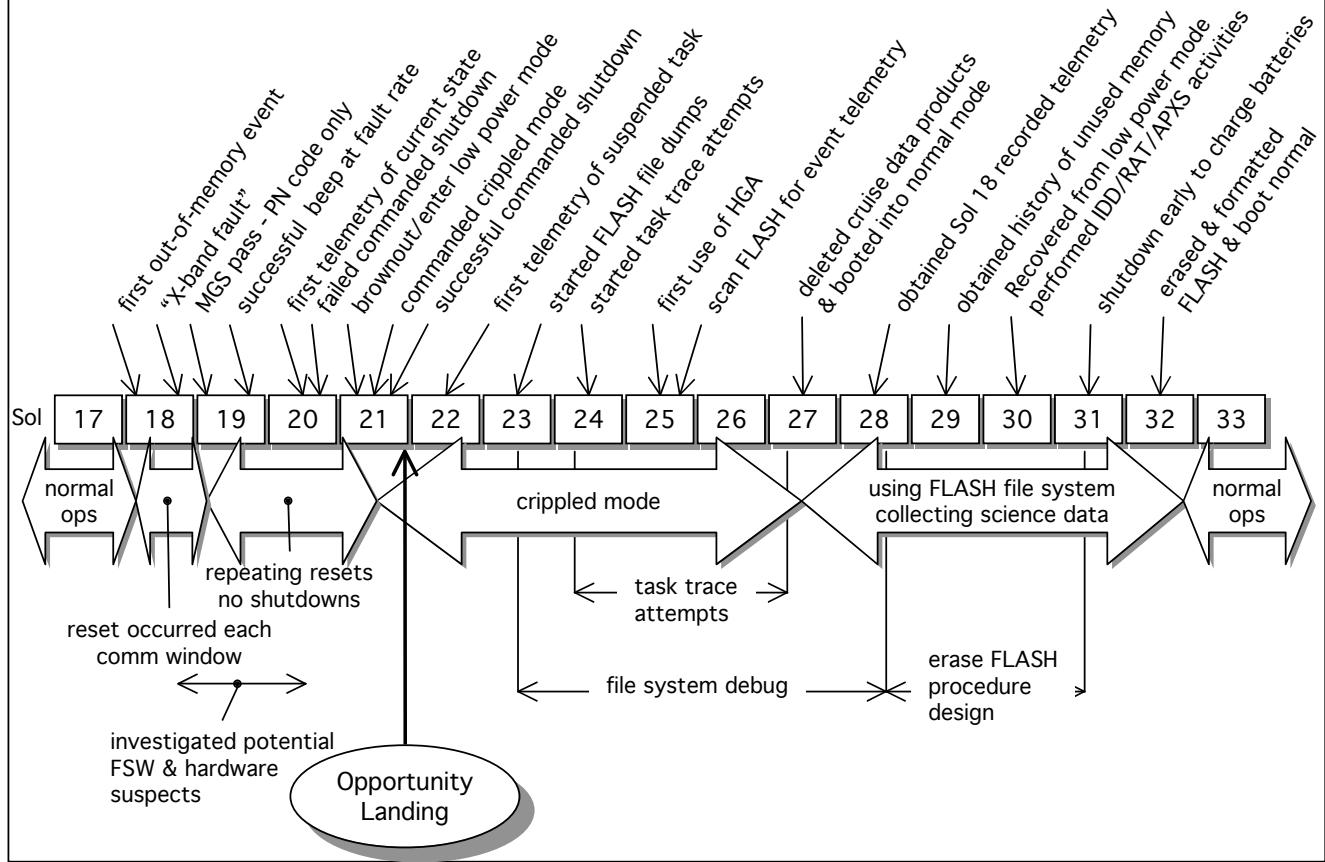
Figure 2: Anomaly events and recovery timeline

and engineering data still in the FLASH memory, and return the vehicle to a science-taking machine. During this time, the press started to refer to us as us “space-age surgeons”. The timeline of the anomaly investigation and recovery is shown in Figure 2.

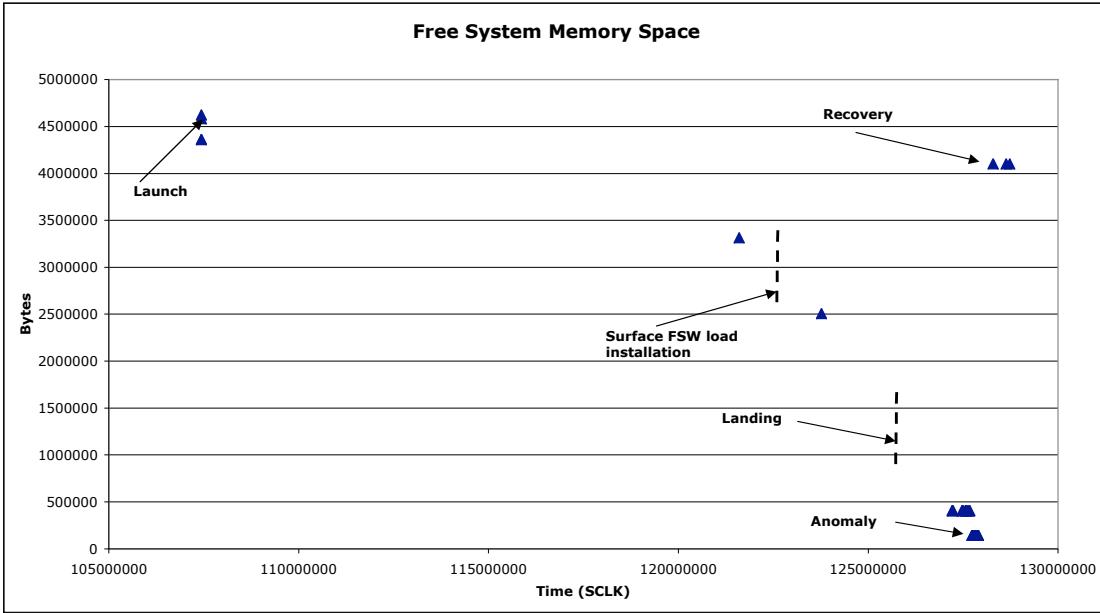
**Figure 3:** Flight telemetry of Spirit's free memory space

Figure 3 shows Spirit’s in-flight telemetry of the free memory space from launch through recovery. Note the segments are not connected on the figure because that would be misleading regarding the rate of decrease in the system memory space. Insufficient data exists to extrapolate when each request for new space occurred. This data was not examined until the anomaly occurred.

*Lesson*—The FSW should have included flight telemetry for resources (such as the free system memory space) so that the actual and expected behavior of the system can be compared.

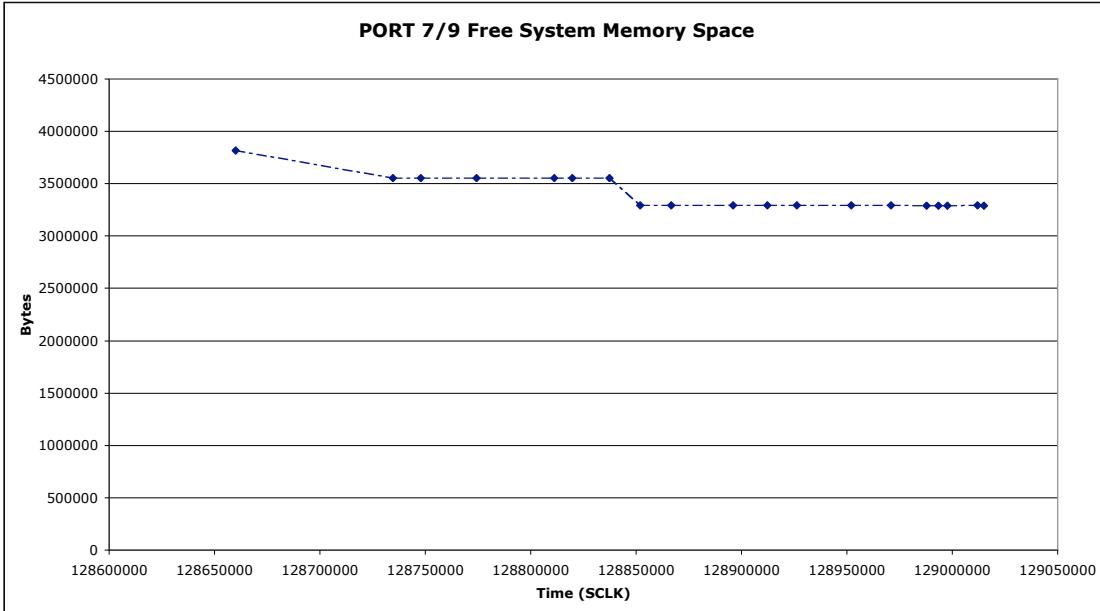
**Figure 4:** Project operational test 7/9 free system memory space

A post-anomaly review of one operational test showed that the memory leak was evident in the data. Figure 4 shows a portion of the telemetry of free system memory space and it indicates a memory consumption trend. The data set is sparse because the telemetry for this data was set to a low priority and was not consistently telemetered. Unfortunately, the team did not analyze this data during the test execution or during the post-test data review.

*Lesson*—A suite of tests and automated analysis tools should have been created early in the development process.

The FSW should have included support for reporting resource usage. The system (FSW, test scripts, ground support equipment) should have included (additional) support for collecting, archiving, and analyzing this information.
