# Challenger Visualization

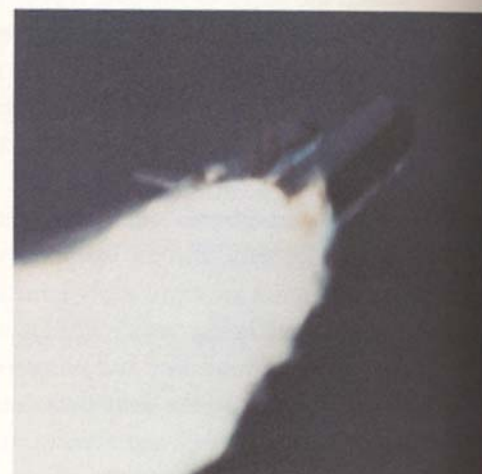
On the launch pad, the leak lasted only about 2 seconds and then apparently was plugged by putty and insulation as the shuttle rose, flying through rather strong cross-winds. Then 58.788 seconds after ignition, when the Challenger was 6 miles up, a flicker of flame emerged from the leaky joint. Within seconds, the flame grew and engulfed the fuel tank (containing liquid hydrogen and liquid oxygen). That tank ruptured and exploded, destroying the shuttle.

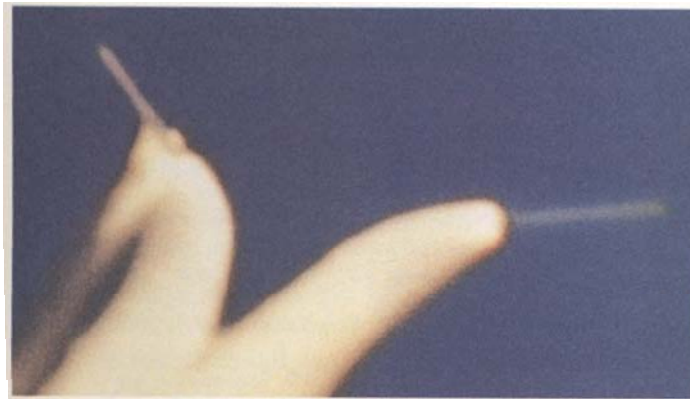
As the shuttle exploded and broke up at approximately 73 seconds after launch, the two booster rockets crisscrossed and continued flying wildly. The right booster, identifiable by its failure plume, is now to the left of its non-defective counterpart.
